DISTRICT OF LOGAN LAKE 2021 ANNUAL WATER REPORT

2021 Annual Water Report

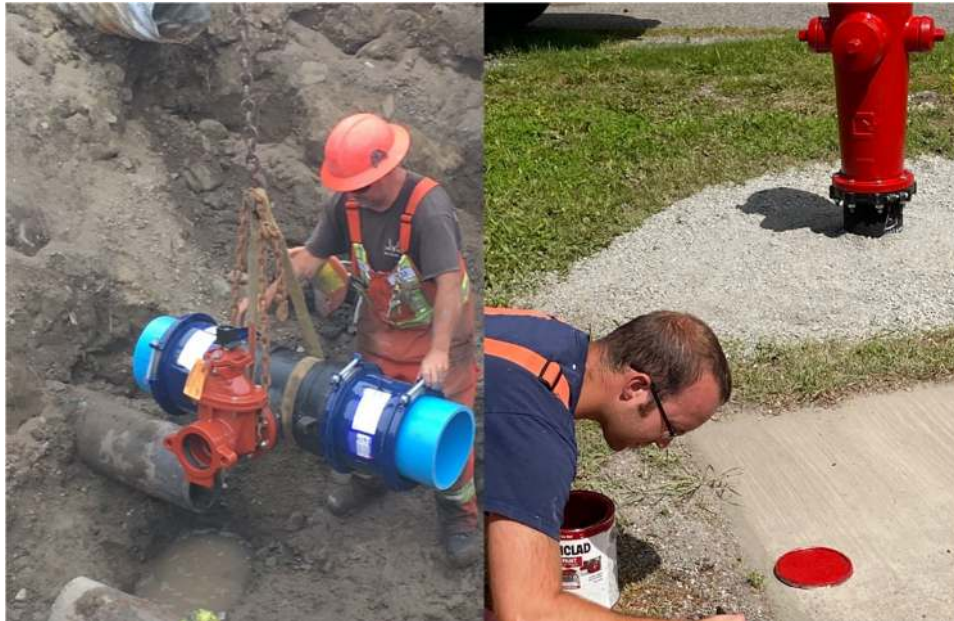
Figure 2: Fire Hydrant Extension and Water Main Repair

Normal operations for the District distribution system consists of a mix of service requests for water connections and water on/offs, annual valve and hydrant maintenance, sampling events, flushing programs and response to small repairs such as curb stops and larger events such as water main breaks. As with most years 2021 contained a fair share of regular maintenance as mentioned above, the unique events included a heat dome in late June which resulted in record volumes of water being pumped in June and the Tremont Creek Wildfire which resulted in staff remaining on site after evacuation to ensure water was available for firefighting needs. Figure 2 includes a couple pictures of the maintenance and repairs seen within the District.

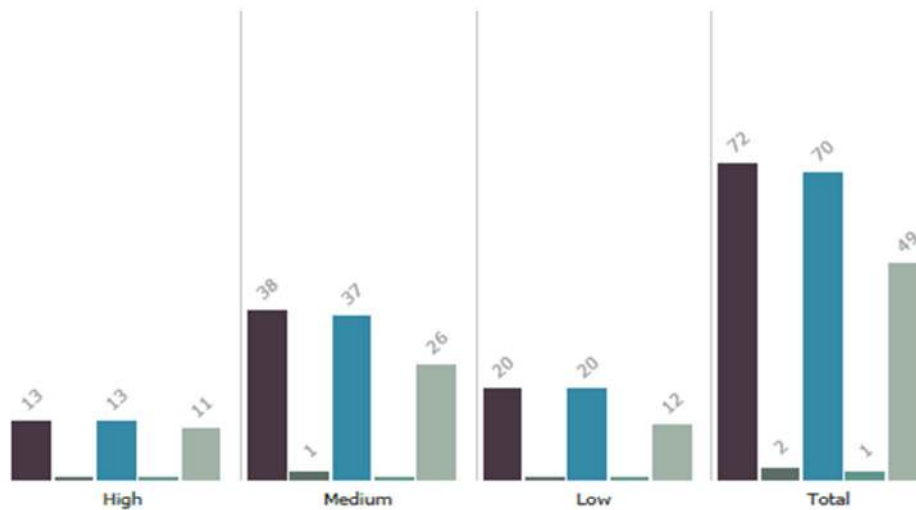
Figure 3: Summary of District CCCP Status for 2021 Year End

The District of Logan Lake has a CCCP that targets industrial, commercial and multi-family residential buildings. The District uses a contractor to manage the program which includes processing test reports and follow up with non-compliant businesses. The District maintains 39 backflow prevention assemblies (BFA) and has two staff certified in cross connection control testing. Figure 3 provides a summary of the District CCCP at the end of 2021 calendar year.

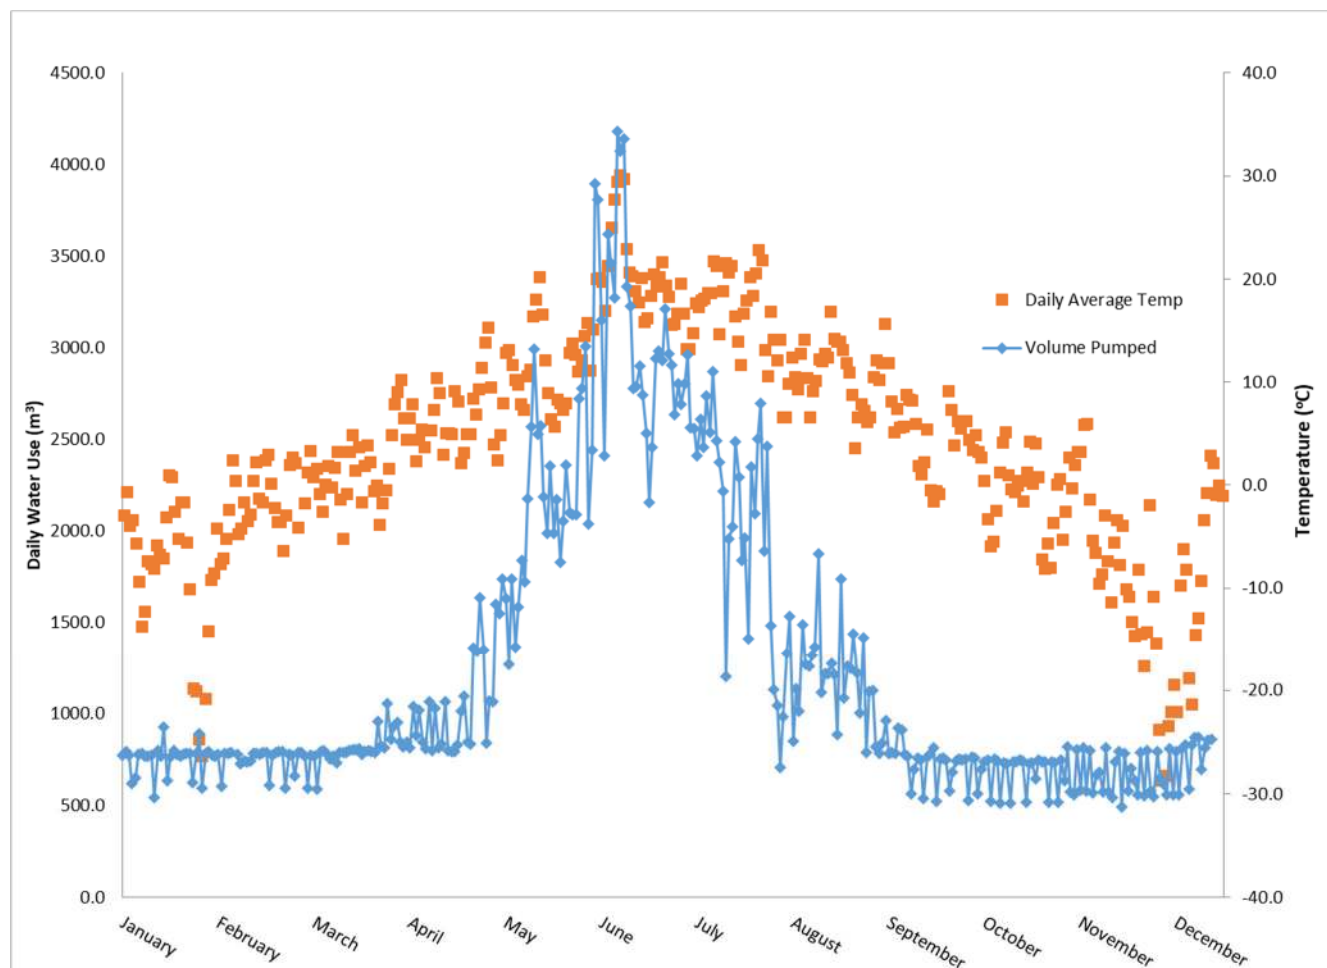
Figure 5: Average Daily Water Use for 2021

The 2021 Calendar year represented the third highest annual production for the past 10 years. Peak day usage was also higher than average with the peak day occurring at the end of June during the heat dome that blanketed much of BC. The Daily Water production can be seen in Figure 5.
